A PICTORIAL STUDY OF  
**SEISMIC  
 DAMAGE**  
 AND THE USE OF  
 PROPER SAFEGUARDS.

On an early January morning in 1994, the Northridge area of Southern California was shaken by an earthquake that measured 6.6 on the Richter scale and lasted approximately 30 seconds. The repercussions are still being felt throughout the engineering community.

The data for the study was accumulated by our structural and mechanical licensed engineers using professional photographers to document site damage.

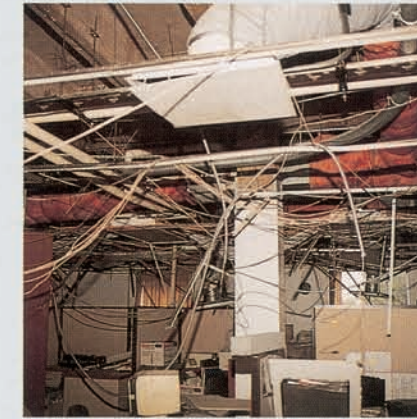
## LAY IN SUSPENDED CEILINGS

Suspended ceilings sustained damage in many installations, because sway wires were not used at all or installed improperly. Damage was extensive and very dangerous to people in the spaces below. Fortunately, the earthquake occurred when most offices were not occupied. Forces in this location were 0.2gV and 0.25gH.

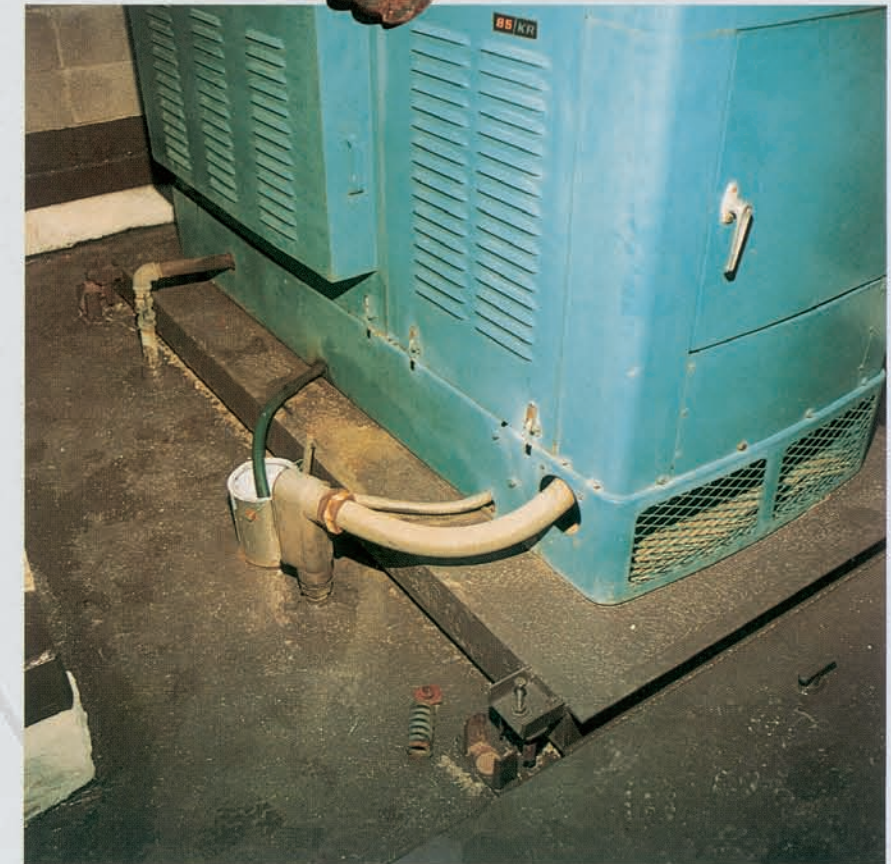
## EMERGENCY GENERATOR

This is a common but unacceptable method of mounting an emergency generator. The generator was bolted to a concrete floating base and supported on springs within gray iron castings. As in other applications, these castings failed to restrain the generator because both the corner rubber inserts and the springs flew out. This design has no upward restraint either. Of all the equipment, every precaution should be taken so the emergency generator remains operational. Failure was total at the very low levels of 0.1gV and 0.15gH. The steel framed reinforced concrete base looks satisfactory, but the supports should have been spring mountings protected by proper snubbers or springs within all directional ductile housings.

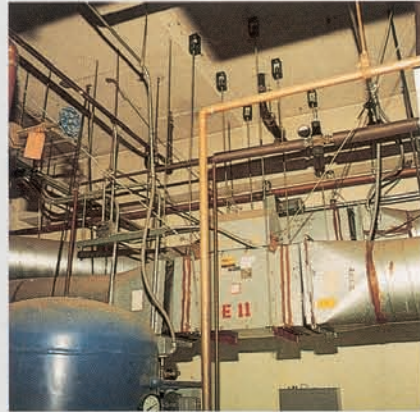
The duct work and piping in this photograph is almost all supported by spring hangers. However, the cable sway bracing kept everything in place and there were no failures in this area.

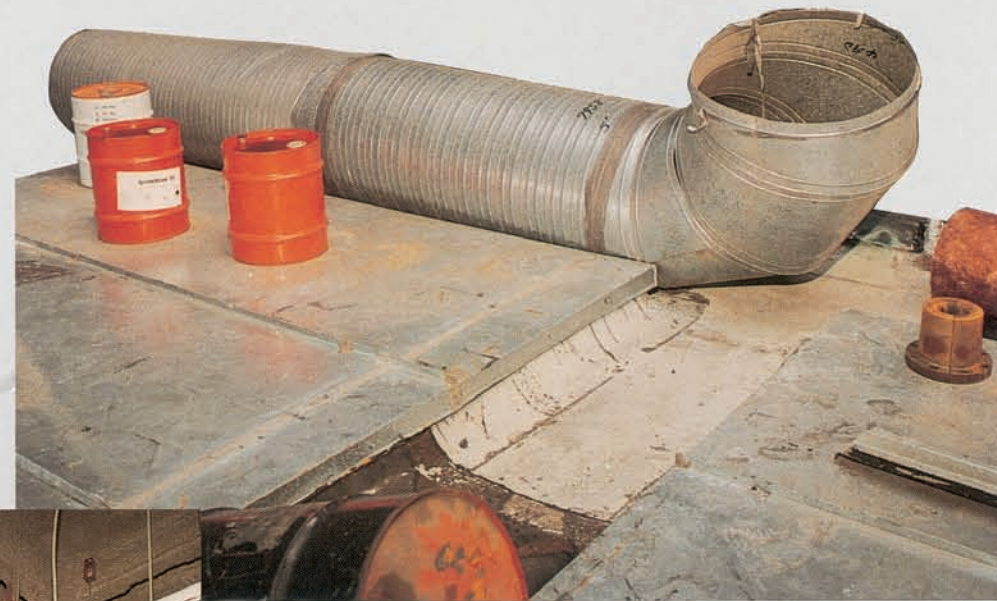
The roof mounted ducts were supported by the steel columns. The four columns were not interconnected, because the loading was so light. However, horizontal forces were large enough to cause failure as the supports were not cross braced to form one integral unit.

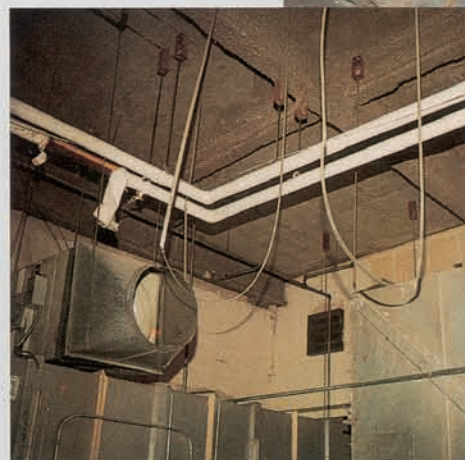
Duct work is very susceptible to seismic damage. Notice the straps that held the ducting that is now on the floor shown in Photograph to the left. This can be prevented by the use of sway bracing to limit sway and keep the duct work in place. Input was 0.15gV and 0.2gH.

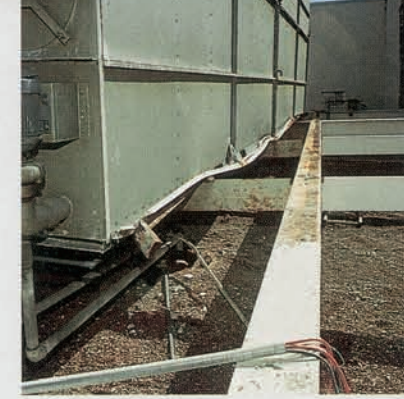
The independent rails rotated around their longitudinal axis, snapping anchor bolts and bending the cooling tower base. The problem could have been prevented by using a one piece structural base and double acting snubbers.

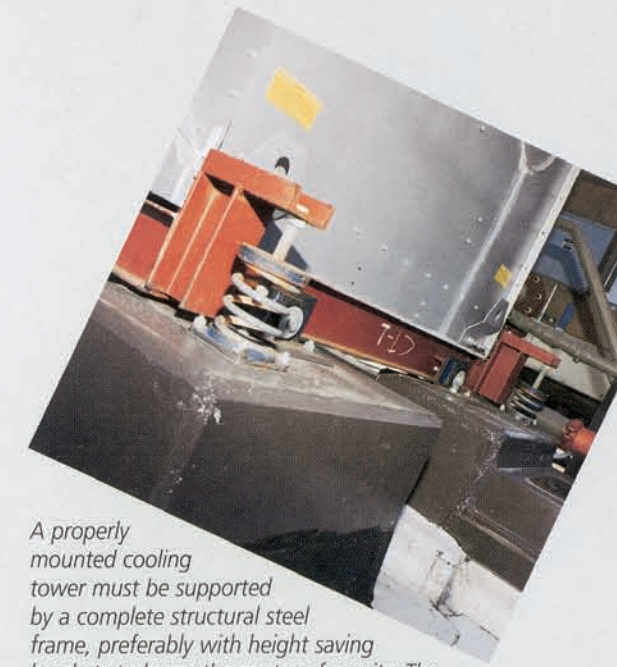
A properly mounted cooling tower must be supported by a complete structural steel frame, preferably with height saving brackets to lower the center of gravity. The free standing spring mountings need not be bolted down, as the blue all directional seismic snubbers next to each spring, limit the spring's motion. These all directional seismic snubbers are shown in Chapter 49 of the 1991 ASHRAE Guide Application Manual. Snubbers are double acting and selected for maximum calculated forces. Springs should be positioned within holders rather than welded to avoid cracking. Adequate edge distance to snubber anchor bolts is extremely important (Mason WF Base, SLF Spring Mountings, Z-1225 Snubbers).

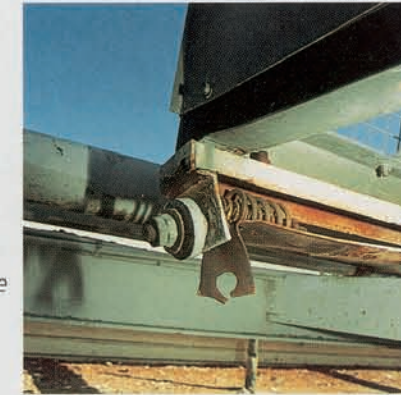
The vertical snubber bolt could not prevent the rail rotation. The anchor bolt tore through the base plate and the support springs fell over.

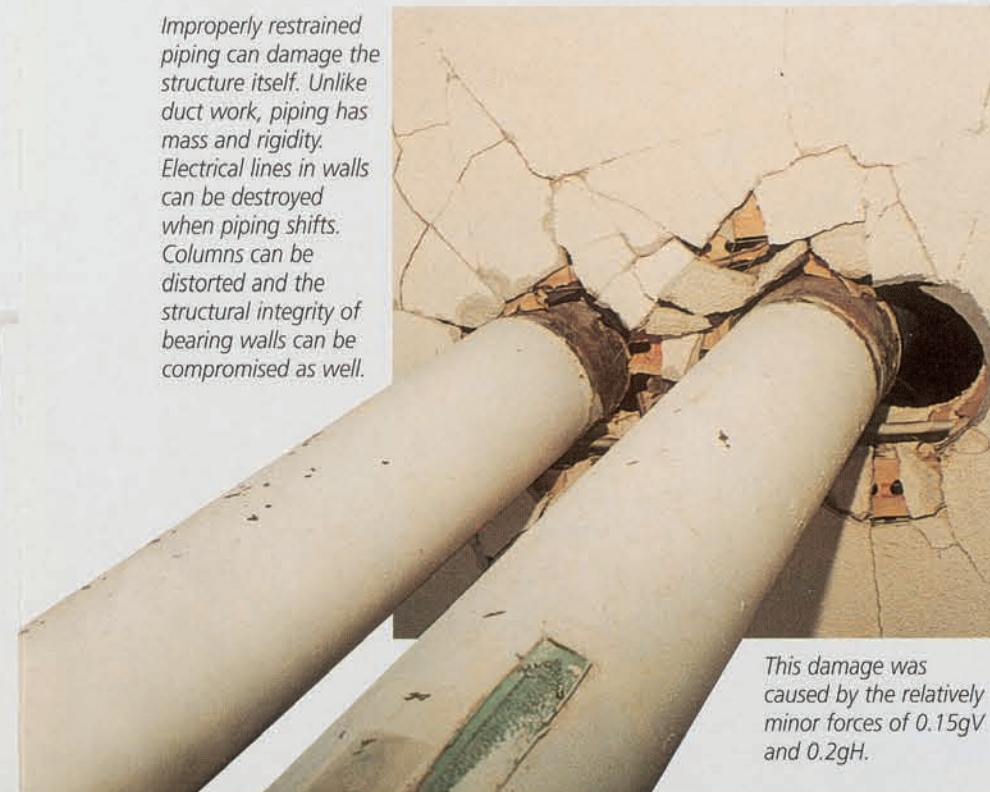
## FLOOR MOUNTED PIPE

Improperly restrained piping can damage the structure itself. Unlike duct work, piping has mass and rigidity. Electrical lines in walls can be destroyed when piping shifts. Columns can be distorted and the structural integrity of bearing walls can be compromised as well.

This damage was caused by the relatively minor forces of 0.15gV and 0.2gH.

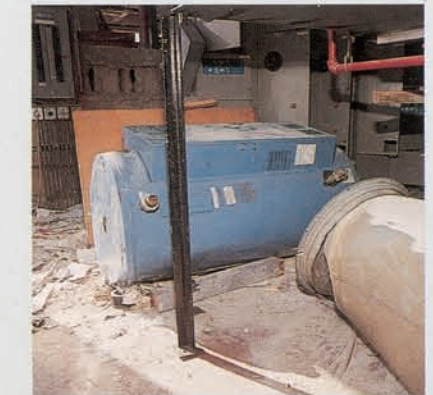
## WATER HEATER

Water heaters have high centers of gravity and tend to turn over easily. The forces on this particular installation were 0.15gV and 0.2gH, heaters should be bolted to the floor and strapped to the nearest wall or column.

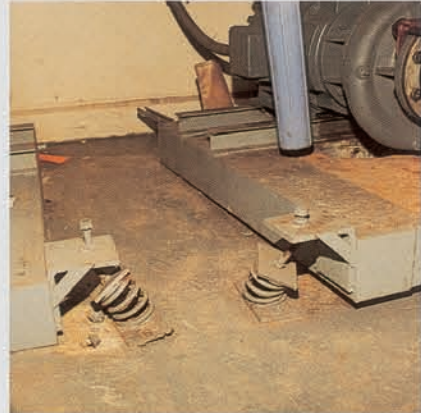
It is unacceptable to consider the horizontal and vertical stiffness of a spring to resist earthquake forces. With no snubbers to limit motion the springs resonate and bend if not break, their attachments. Anchor bolts can bend or shear off when the springs themselves do not fail or fall over. The attachment of proper snubbers to the steel frame would have averted this disaster.

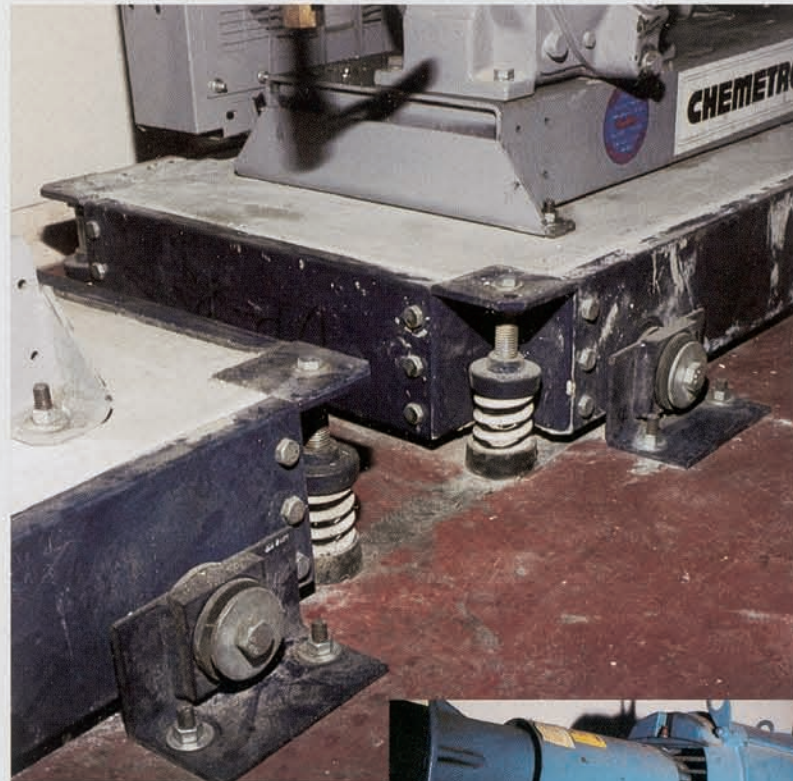
Another example showing free standing springs cannot be used without snubbing devices. The anchor bolts under these spring mountings were too close to the edge, and broke the housekeeping pad. Forces were relatively low at 0.2gV and 0.25gH, but more than sufficient to create havoc on this unsnubbed, resonant system.

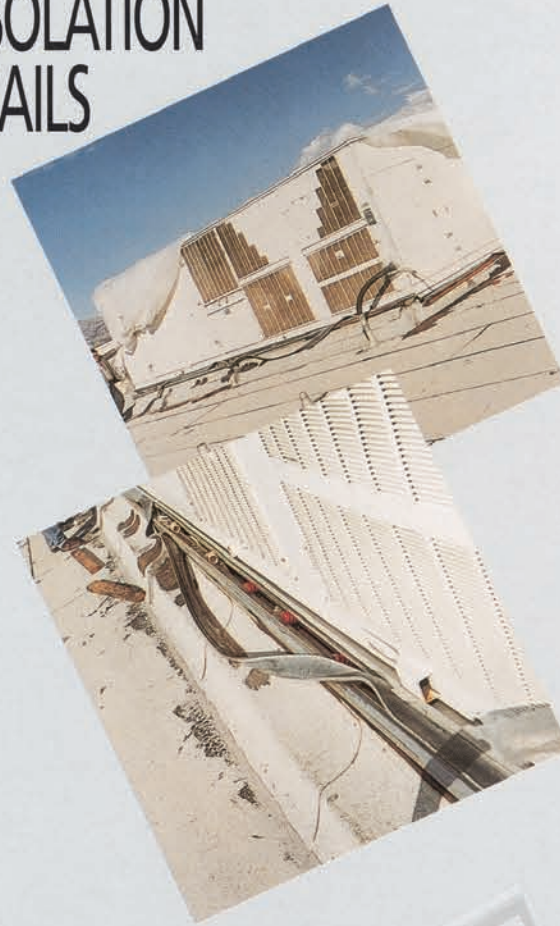
This properly designed seismically rated spring curb had resistances based on testing to allow for seismic input. The input forces were approximately 0.2gV and 0.25gH. The spring curb prevented damage to the lower support curb and the internal components of the unit.

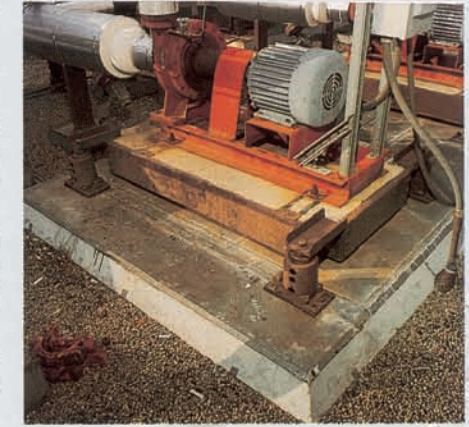
Mounting a pump directly on mountings without a supplementary steel or concrete base is bad practice because of pump coupling alignment problems when torque twists the bases. The mounting housings proved inadequate as the vertical restraining bolts failed. The restraining angles bent and either the anchor bolts were sized inadequately, of the wrong type or poorly installed as the anchorage broke free and the pump shifted out of position. Input was a low 0.2gV and 0.25gH.

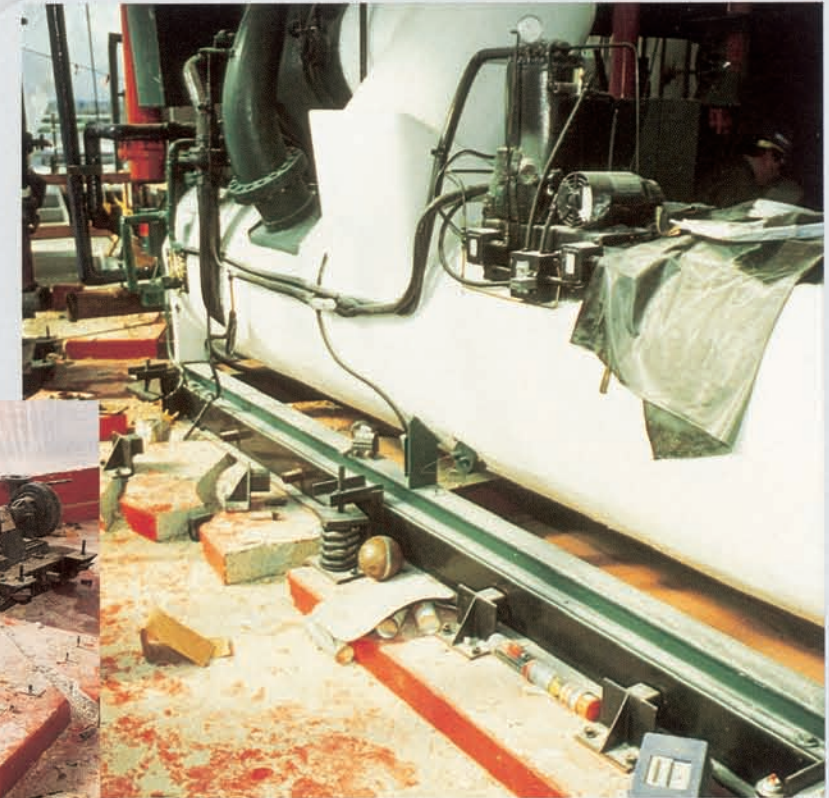
# HOUSEKEEPING PADS

Housekeeping pad failures were common, because of improper doweling or fastening to the structural floor, and inadequate or no reinforcement in the pad itself. These pads, as the pads on the cover, had both problems. Inadequate fastening allows the pads to lift, chatter and shift. Poor reinforcement allows breakage. When the pads fail, the system must fail as nothing remains in place.

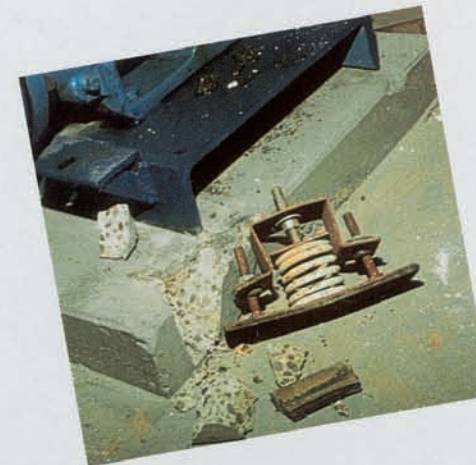
The anchor bolts were too close to the edge of the concrete housekeeping pad for the concrete to offer adequate resistance to the horizontal anchor bolt forces. The edges broke off so the anchor bolts were freed. This total failure of the restraint system occurred at only 0.15gV and 0.15gH. The mountings themselves showed considerable distortion as well.

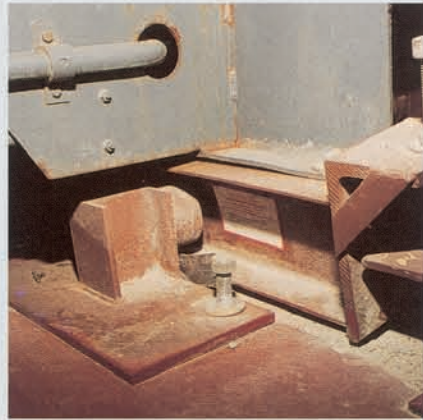
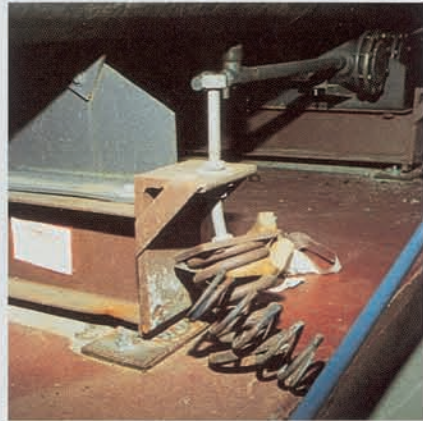
Rails rotated in virtually every application. In the upper photograph the rotation was initiated by the horizontal snubber pushing against the web of the beam. In both photographs the springs were secured by welding. Welding is always poor practice as the intense heat embrittles the spring so it tends to snap at the weld and scale inclusions produce welds that pop off. All systems failed with pipe breakage in addition to the other problems.

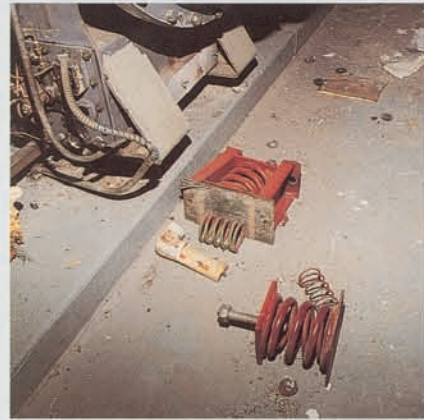
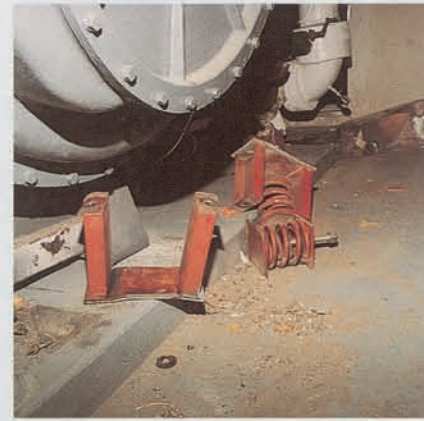
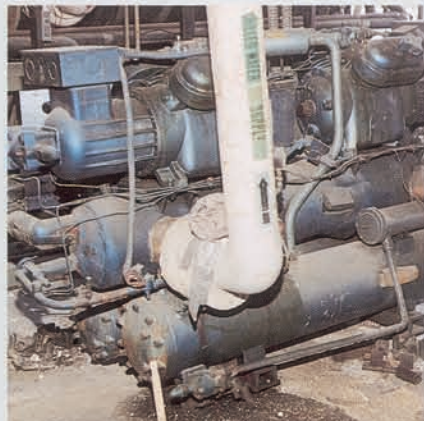
Another example of gray iron mounting failure. Fragments shown in the lower left and lower righthand corners can be dangerous to building personnel as well as equipment. Not only is the compressor out of service, but there is the additional worry of potential liability and damage.

Some chillers can be directly mounted on spring isolators, but not as shown in photographs above. Seismic forces were reasonably high at 0.3gV and 0.6gH. Not all the parts are shown in the photographs, but both the restraining bolts between the upper and lower housings and the anchor bolts failed. The top plates came free of the rest of the housing and may still be attached to the chiller. Base plates were weak and showed distortion. Mountings rated by test with OSHPD pre-approval would have been far safer. The chiller dropped some 14" in addition to shifting.

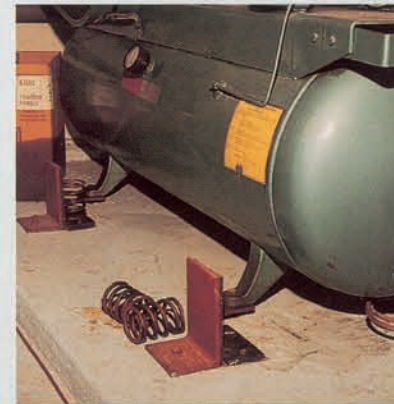
The spring mountings under this air compressor failed, because the snubbers were not all directional. Single bolted restraints can rotate. This angle had a simple pad cemented to one face. The arrangement could only contain the system transversely rather than in all directions. As is typical, the equipment resonated and the springs fell over. Forces were about 0.25g Vertical and 0.35g Horizontal. Proper all directional snubbers would have solved the problem.

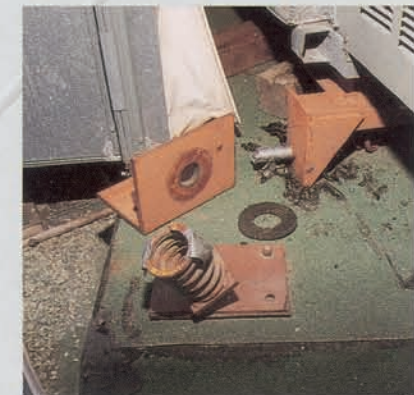
Using a poor copy of a good snubber can result in disaster. Rather than a snubber made with a one-piece double acting, all directional Neoprene sleeve with washer faces, this hard rubber washer was cemented to the angle. The rubber bushing does not appear to be thick enough. The minor cost saving, if any, resulted in a dramatic, costly failure and major equipment displacement.

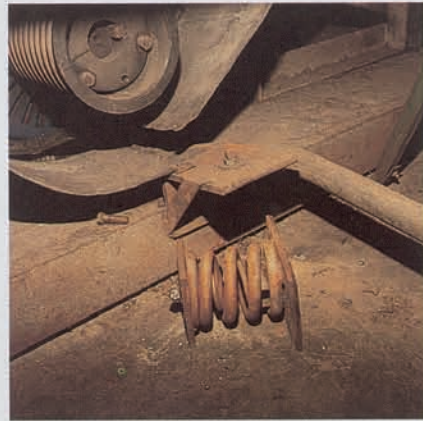
This close up of the spring shows that the attachment bolt broke allowing the spring to shift and fly free. (The spring was moved back for the photograph.) This would be a dangerous missile anywhere, but particularly in an equipment room with electrical devices. Proper snubbing would have controlled the situation.

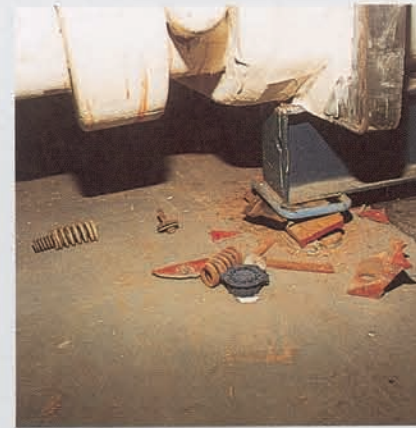
Here is another example of ragged, shattered pieces of cast iron. Cast iron should not be approved for seismic work regardless of the force levels. The systems were subjected to low inputs of 0.2gV and 0.25gH.

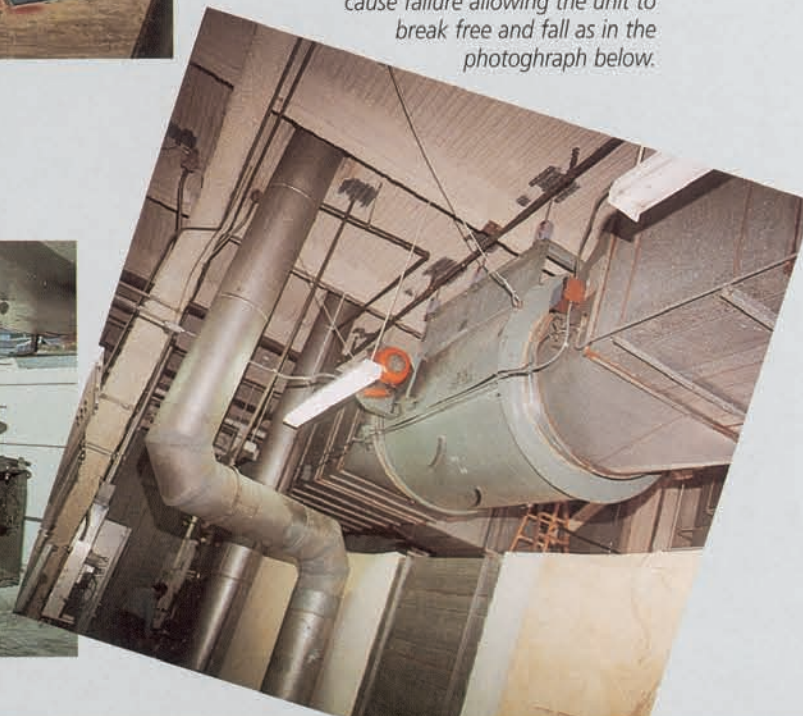
## SUSPENDED FANS

This small tubular fan broke free of the ceiling and landed on the mechanical room floor. It could have caused severe injury or equipment damage. Electrical lines and control panels are particularly sensitive. This swinging almost always takes place when seismic energy is applied to suspended systems. Proper cable sway bracing would have limited the pendulum action.

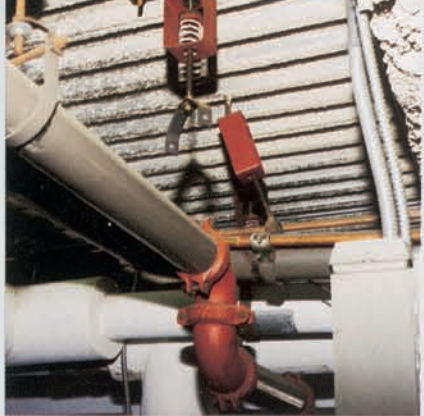
The clevis hanger in the center of the photograph fell apart and the rear hanger clevis is sufficiently displaced to have bent the ceiling bolt. There are chatter marks on the pipe in the front clevis, all indicating that this system went into resonance even though the accelerations were only 0.15gV and 0.2gH. Proper sway bracing, axial restraint and upper limit stops could have prevented this damage.

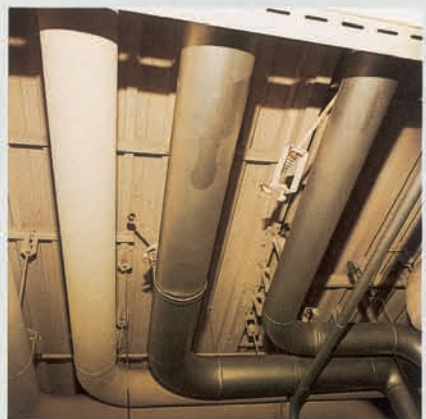
Piping without sway braces will shift position and change elevation. One hanger broke completely free and one pipe is displaced approximately 12" from its original location. On other jobsites, piping systems came down. Sway bracing and axial restraint is essential along with vertical limit stops at anchorage locations. Clevis bolts must be sleeved or braced as well.

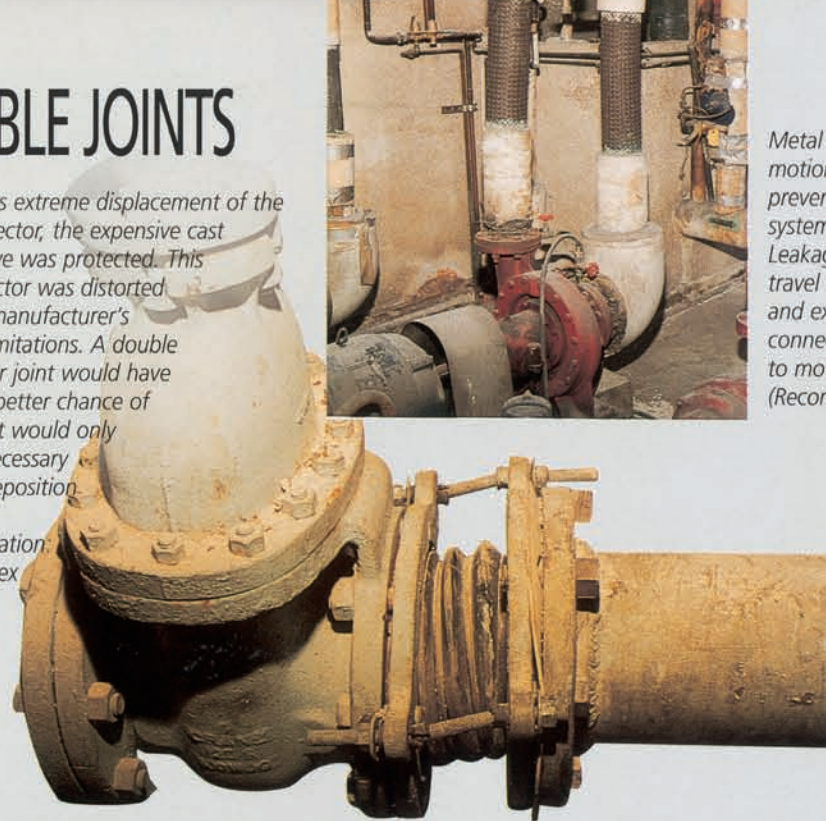
Even with this extreme displacement of the flexible connector, the expensive cast iron gate valve was protected. This teflon connector was distorted beyond the manufacturer's movement limitations. A double sphere rubber joint would have had a much better chance of survival and it would only have been necessary to properly reposition the piping. (Recommendation: Mason Safeflex SFDEJ)

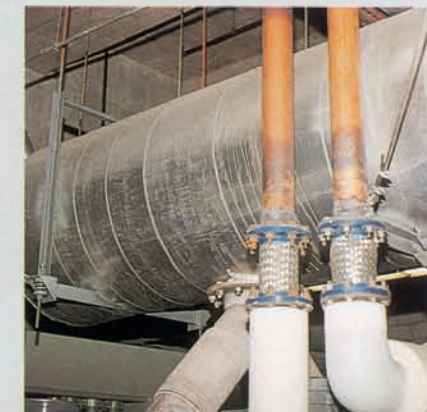
Metal flexible hose is designed to accept motion at right angles to the axis. The hoses prevented pump body failures, but after the system was back on line, the hoses leaked. Leakage was caused by metal fatigue, over travel transverse to the axis or compression and extension. Double sphere rubber connectors are all directional and can respond to motion in any direction without failure. (Recommendation: Mason Safeflex SFDEJ)

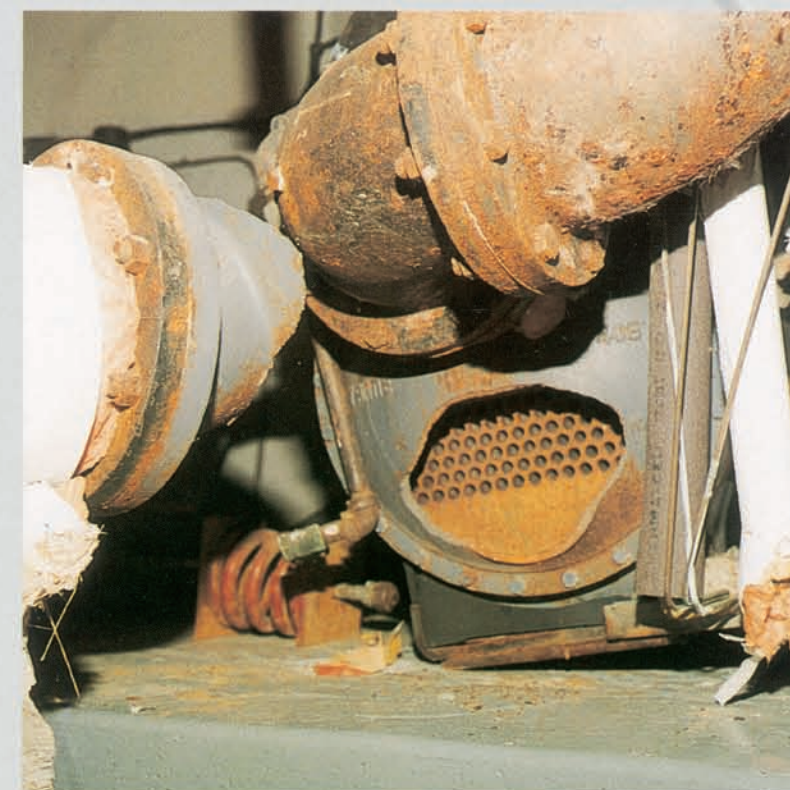
## PIPE CONNECTION TO CHILLER

An excellent example of equipment failure at the piping interface. Both the restrained equipment and piping move out of phase during an earthquake and the cast shells are not designed to accept the force necessary to drag the piping. Cast component failures are common. The solution is installation of a spherical twin sphere rubber expansion joint to allow for the motion.
