A PICTORIAL STUDY OF  
**SEISMIC  
 DAMAGE**  
 AND THE USE OF  
 PROPER SAFEGUARDS.

On an early January morning in 1994, the Northridge area of Southern California was shaken by an earthquake that measured 6.6 on the Richter scale and lasted approximately 30 seconds. The repercussions are still being felt throughout the engineering community.

The data for the study was accumulated by our structural and mechanical licensed engineers using professional photographers to document site damage.

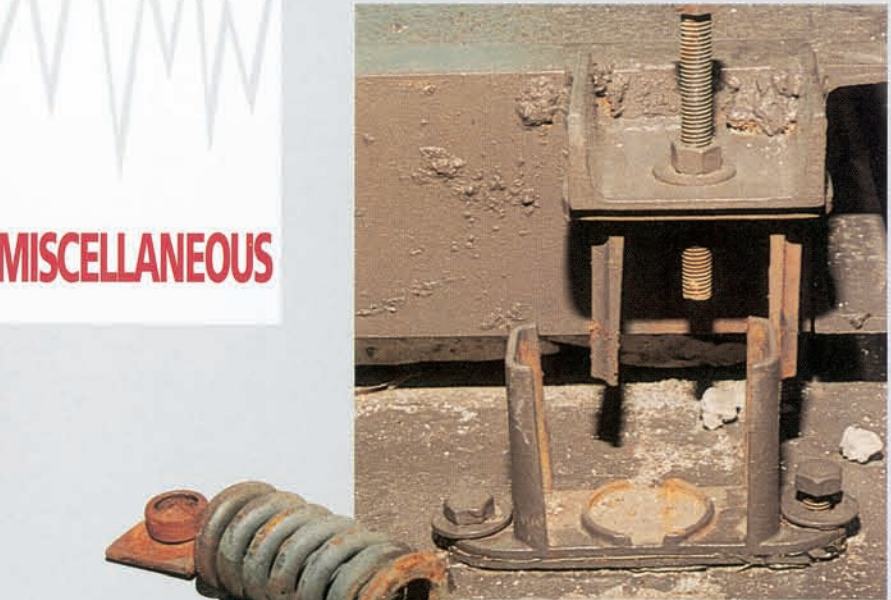
This is a common but unacceptable method of mounting an emergency generator. The generator was bolted to a concrete floating base and supported on springs within gray iron castings. As in other applications, these castings failed to restrain the generator because both the corner rubber inserts and the springs flew out. This design has no upward restraint either. Of all the equipment, every precaution should be taken so the emergency generator remains operational. Failure was total at the very low levels of 0.1gV and 0.15gH. The steel framed reinforced concrete base looks satisfactory, but the supports should have been spring mountings protected by proper snubbers or springs within all directional ductile housings.

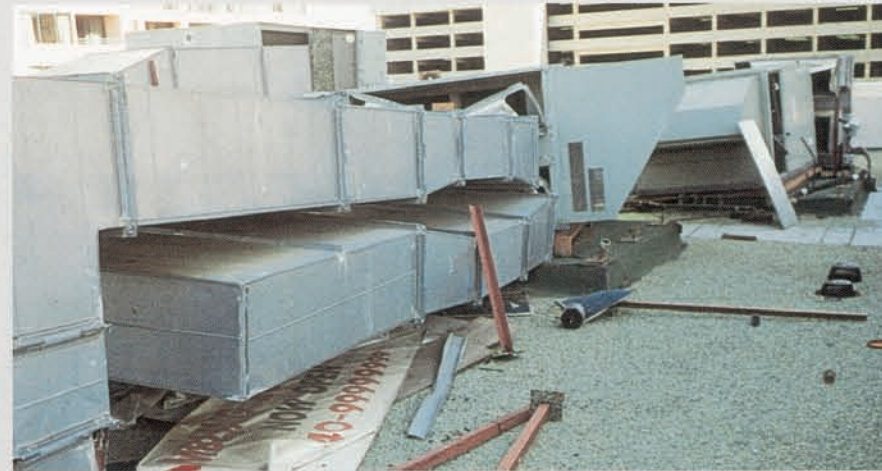
The roof mounted ducts were supported by the steel columns. The four columns were not interconnected, because the loading was so light. However, horizontal forces were large enough to cause failure as the supports were not cross braced to form one integral unit.

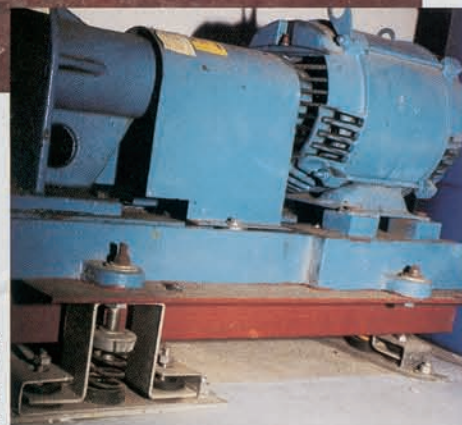
This pump system is mounted on a steel frame to minimize floor loading. The springs are inside a steel seismic housing with all directional elastomeric grommets to prevent hard surface impact. Anchor bolt edge distance was more than adequate and the system showed no sign of failure. (Mason MSL Base, SLRA Spring Mountings with extended base plates)

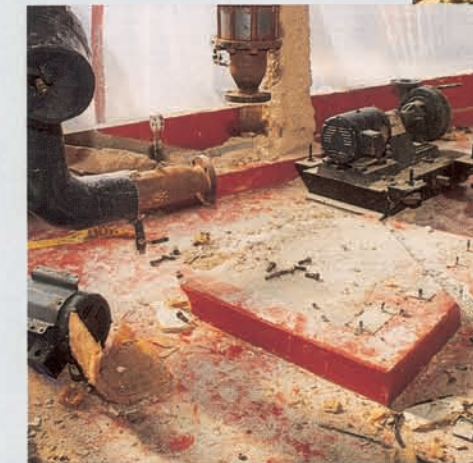
Housekeeping pad failures were common, because of improper doweling or fastening to the structural floor, and inadequate or no reinforcement in the pad itself. These pads, as the pads on the cover, had both problems. Inadequate fastening allows the pads to lift, chatter and shift. Poor reinforcement allows breakage. When the pads fail, the system must fail as nothing remains in place.

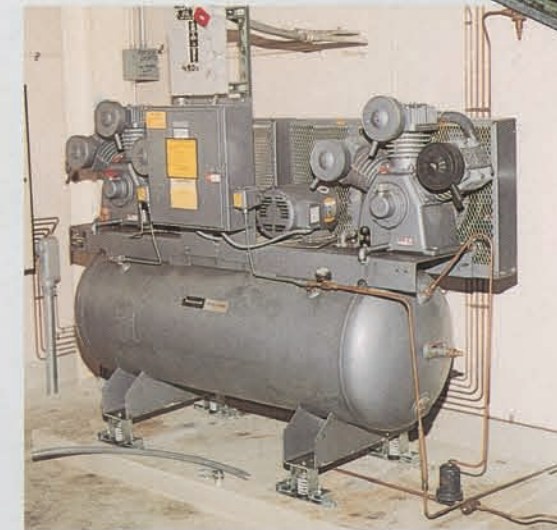
This is a simple isolation method for a horizontal tank mounted compressor (if the base legs are sturdy enough) without the use of a supplementary steel base. Mountings have built in seismic snubbers with ratings from OSHPD in the State of California. Not only these mountings, but similar designs were successful in every reviewed location. Forces were approximately 0.2gV and 9.25gH. (Mason SLRA Mountings)

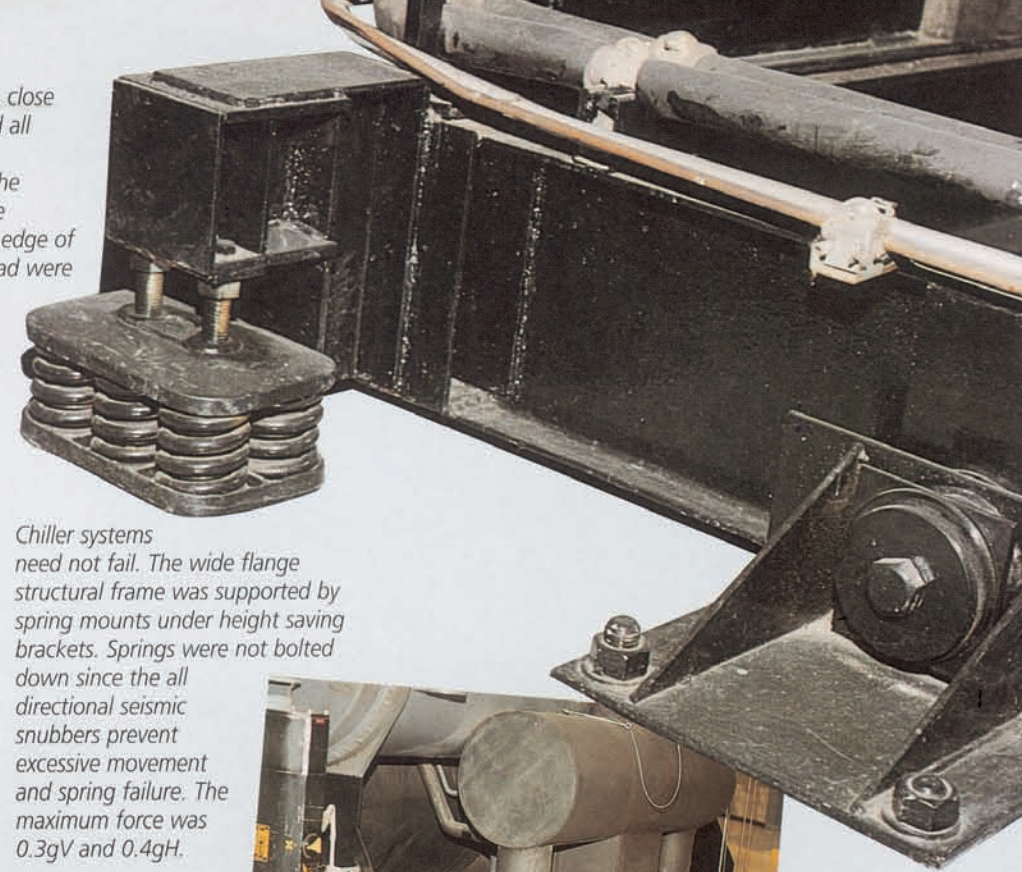
Chiller systems need not fail. The wide flange structural frame was supported by spring mounts under height saving brackets. Springs were not bolted down since the all directional seismic snubbers prevent excessive movement and spring failure. The maximum force was 0.3gV and 0.4gH.

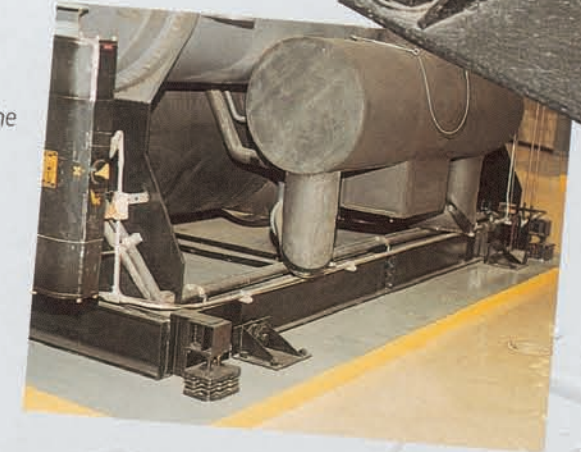
One of the proper ways to mount a fan and motor is to bolt the equipment to a rigid rectangular steel base. The spring mountings friction pads eliminate the need for bolting as the snubbers will limit motion. All directional thick Neoprene snubber bushings both restrain and cushion shock. (Mason WF Base, SLF Springs, Z-1225 Snubbers)

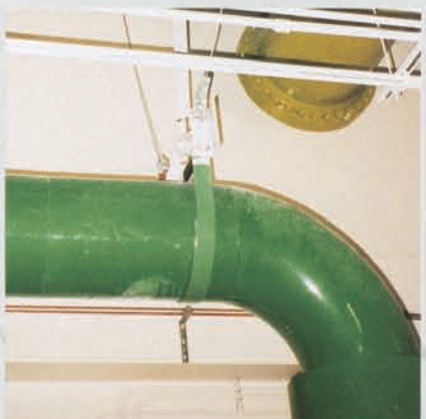
A typical example showing the use of a cable sway brace with swivel fittings for the specific purpose. Fittings are adjustable and the installation simplified by their use. (Mason Type SCB)

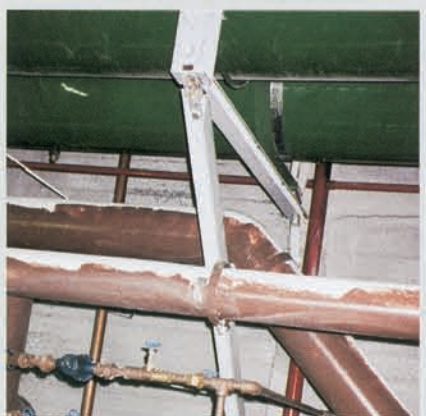
The swivel sway brace fittings at the ends of the angle iron brace eliminate welding, fitting and fabrication time. Solid sway braces can only be used on equipment that is not isolated. When equipment is isolated, bracing must be by cable or isolated devices to prevent transmission of vibration. (Mason SSB)

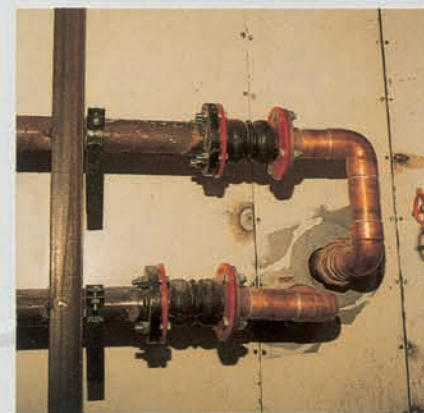
An excellent example of equipment failure at the piping interface. Both the restrained equipment and piping move out of phase during an earthquake and the cast shells are not designed to accept the force necessary to drag the piping. Cast component failures are common. The solution is installation of a spherical twin sphere rubber expansion joint to allow for the motion.
