# Effects of Seismic Inputs on Resiliently Mounted Mechanical Equipment

Patrick J. Lama, Mason Industries, Inc., Hauppauge, New York

Earthquake control of resiliently mounted systems is an area of primary concern for acoustical and mechanical engineers. The Northridge, CA earthquake of January 17th, 1994, provided several valuable lessons regarding protection of these systems. The lessons learned from this earthquake are highlighted with actual site photographs that are useful and dramatic. The photographs are combined with several tables and illustrations that provide practical guidelines for future mechanical system installations.

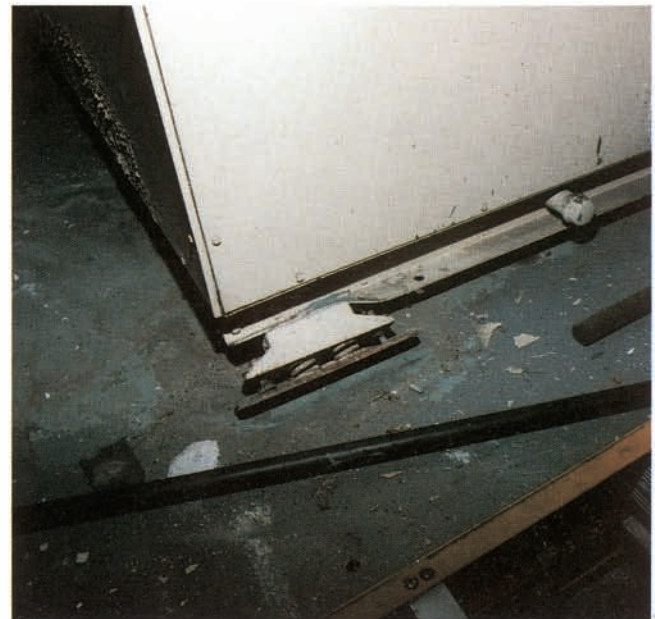
Figure 5. Direct mounting of vibration isolators can result in failure if the machinery frame is not adequate and local buckling occurs (roof location, 2 stories, approximate maximum seismic excitation - 0.42 g horizontal, 0.3 g vertical).

plest connection to look at is the connection of the seismic snubber to the isolated equipment or equipment frame. This connection is the easiest to deal with since the structural integrity of the equipment leg or frame is not complex to investigate. When in doubt, use a structural frame (steel or concrete). Do not use rails, since recent studies indicate rails fail. Figures 5 and 6 show improper systems and Figure 7 shows a system that is proper at this interface connection.

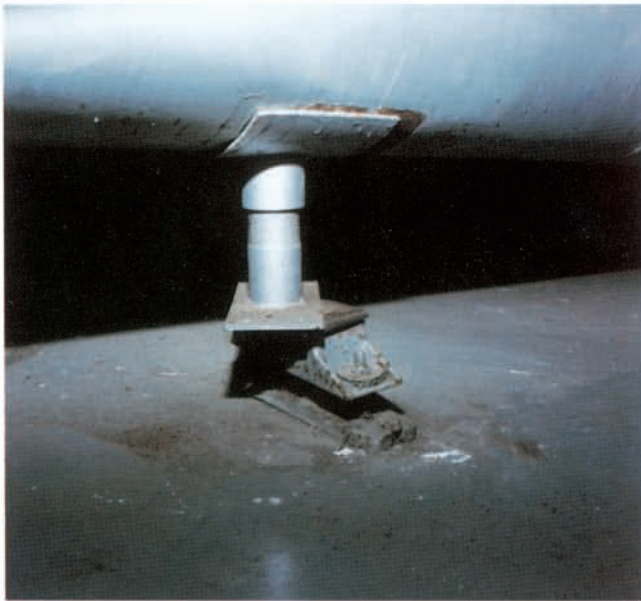
Figure 6. The attachment of the stand to the pipe and to the top of the machinery mount is not proper. This allowed the stand to shift off the mounting (basement location, 6 stories, approximate seismic excitation - 0.3 g horizontal, 0.25 g vertical).

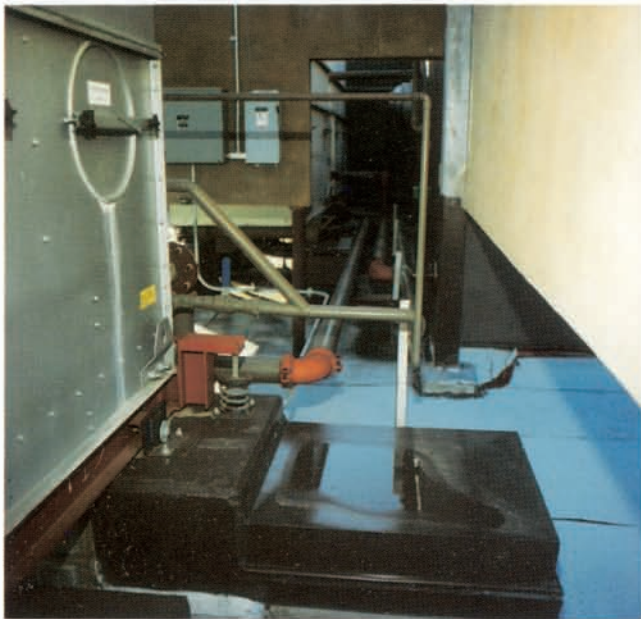
Figure 7. The cooling tower is mounted on a proper structural frame with all-directional Z-1011 seismic snubbers. The result is no failure with the cooling tower remaining operational (roof location, 8 stories, approximate maximum seismic excitation - 0.45 g horizontal, 0.32 g vertical).

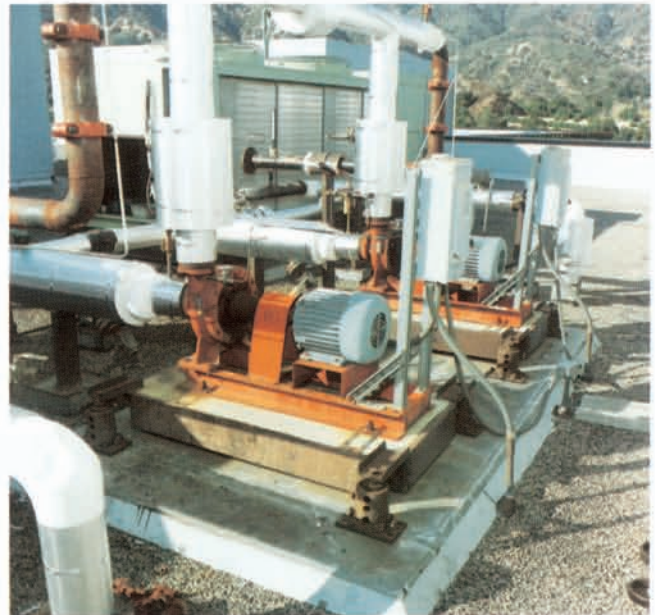
Figure 8. The seismic snubbers are built into the vibration isolators. The system was properly adjusted and withstood the effects of over 2 g input and remained operational. The mounting type is Mason SSLFH (roof location, 7 stories, approximate maximum seismic excitation - 2.3 g horizontal, vertical n/a).

Several of these systems are shown in Figure 8. These units have fared very well during the Northridge earthquake and withstood input accelerations over 2 g horizontal. This is the highest input magnitude ever recorded anywhere in the world.

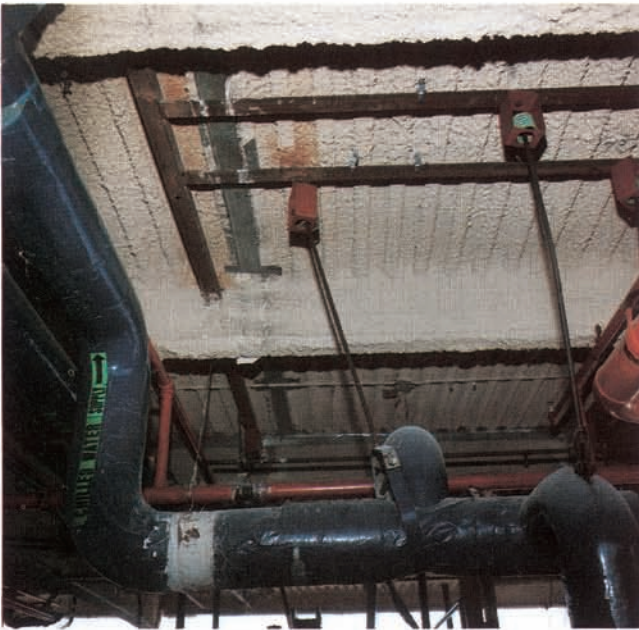
Figure 11. Pipe support rods were displaced which caused the piping to distort. The pipe distortion is expensive to repair (8th floor location, 8 stories, approximate maximum seismic excitation - 0.36 g horizontal, 0.22 g vertical).

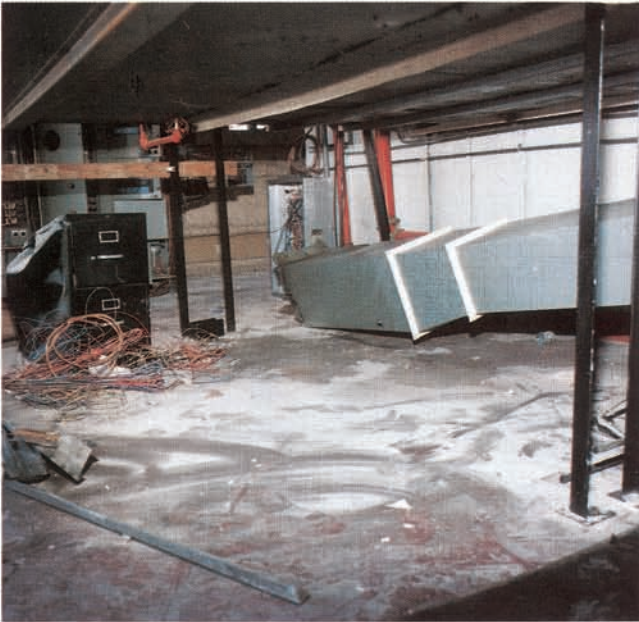
Figure 12. Duct failure resulted when sway braces were omitted (4th floor location, 4 stories, approximate maximum seismic excitation - 0.4 g horizontal, 0.28 g vertical).

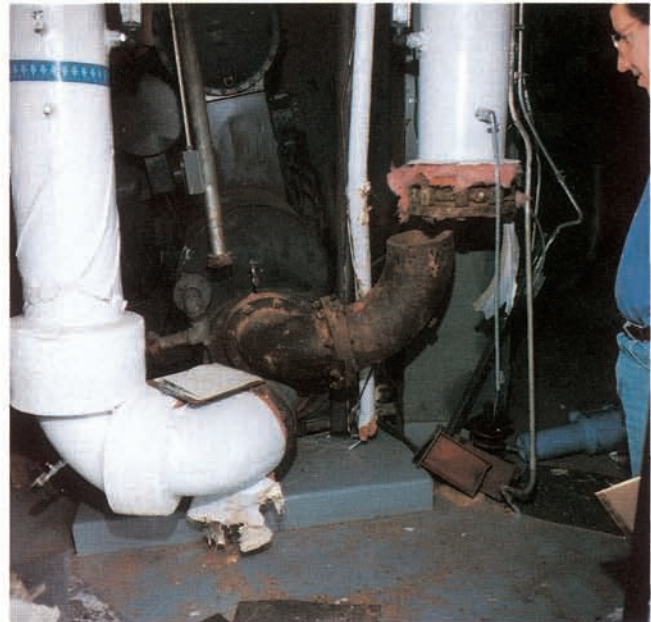
Figure 14. Piping failures at interface connections can be prevented with the use of elastomeric joints (15th floor location, 15 stories, approximate maximum seismic excitation - 0.4 g horizontal, 0.28 g vertical).

Earthquakes do cause structural building elements such as floors, walls and ceilings to move out of phase. This poses a problem at the pipe and equipment interface. To prevent pull-out failure as shown in Figure 14, an elastomeric expansion joint must be used. It is recommended that a fail safe design with a flat ring instead of a wire at the flange and hose body interface be used to prevent body pull-out.

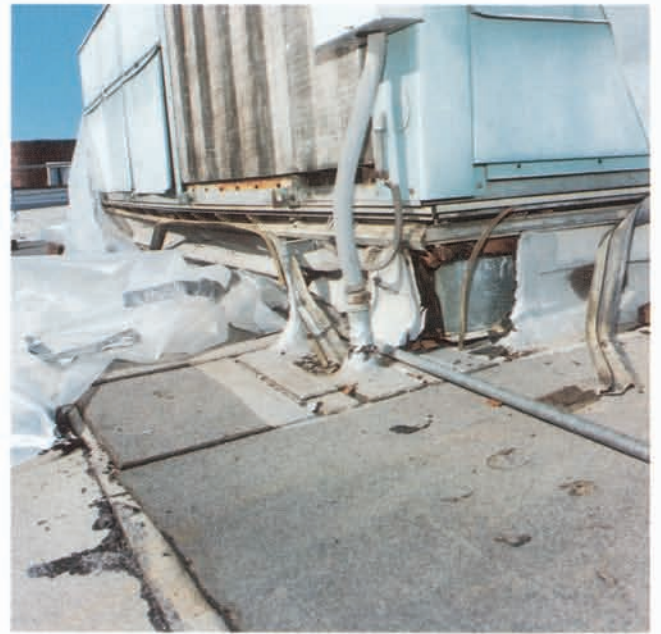
Figure 16. Isolated aluminum roof curbs failed because of the lack of structural strength of the aluminum sections (roof location, 4 stories, approximate maximum seismic excitation - 0.3 g horizontal, 0.22 g vertical).

Two other types of systems that had high failure rates were isolated aluminum roof curbs and internal isolation systems. The main cause of failure of isolated curbs was the lack of structural strength of the aluminum itself. Figure 16 illustrates the type of collapse the aluminum curbs experienced. This type of failure is difficult to fix. The unit must be lifted off the roof in many cases by a crane with a large boom. In some cases a helicopter lift is necessary. The aluminum frame is replaced and this unit re-rigged into place. The electrical, plumbing and duct connections are then re-connected. This is an involved process that can be avoided by using isolated steel roof curbs Mason type RSC. There were no roof curb failures using this type of unit.
